Manhole Inspection Summary

Manhole # S45I__006MH

Insp Date: **10/31/08 9:28 AM**

Location Address: **417 s ann st**

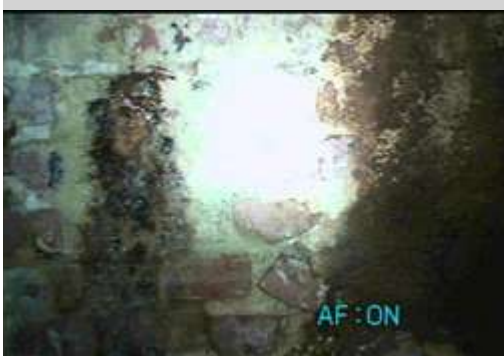
Defect 3

Infiltration: ☐ None ☐ Joint ☐ Cracks ☐ Mortar ☐ Roots ☒ **Wall**

infiltration in barrel wall

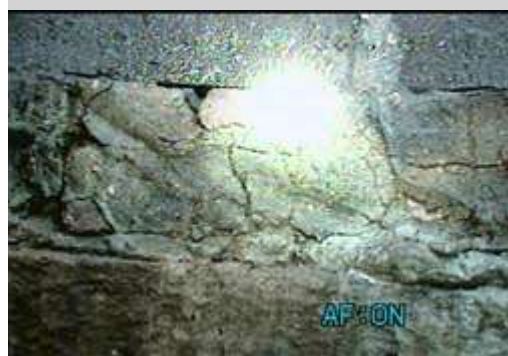
Defect 2

Condition: ☐ Sound ☒ **Cracked** ☐ Root Intrusion ☒ **Loose Brick** ☐ Deteriorated

Infiltration: ☐ None ☒ **Joint** ☐ Cracks ☐ Mortar ☐ Roots ☐ Wall

cracks and loose bricks in chimney with infiltration at joint

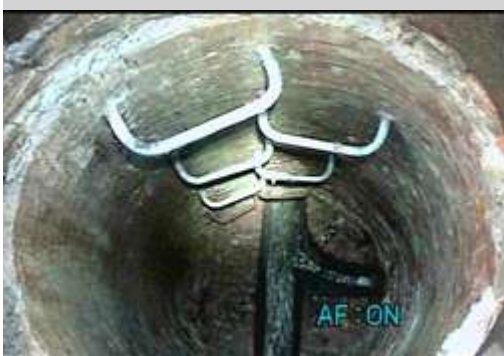
Defect 1

Count: **8** Missing: **0** ☒ **Corroded**

cor. steps
